WATER DAMAGE/REMEDIATION ASSESSMENT

**Hull High School
180 Main Street
Hull, Massachusetts**

Prepared by:
Massachusetts Department of Public Health
Bureau of Environmental Health
Indoor Air Quality Program
February 2018

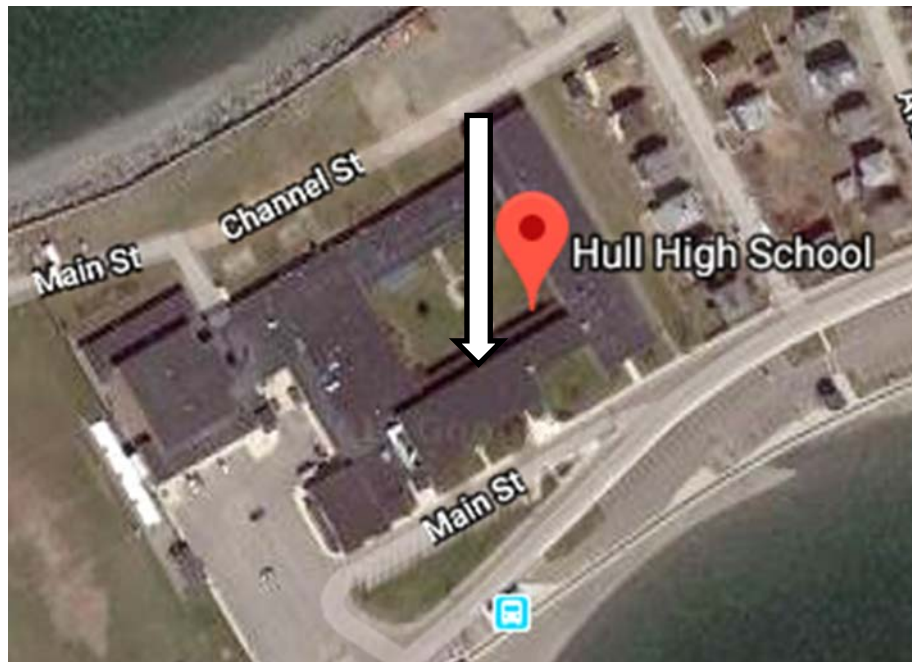
Picture 1

Areas of concern focused on water penetration issues from the central courtyard and in the gym foyer. As reported by school officials, periodic rain water enters the main hallway around exterior doors periodically during heavy wind/weather events (Pictures 1 through 3). BEH/IAQ staff examined doors in the courtyard and noted that weather-stripping was dry/brittle and damaged (Pictures 4 and 5). Although, this source of leaks should be addressed, there were no porous building materials that can harbor mold growth (e.g., carpet, drywall) in the affected area. The areas impacted consist of floor tile, metal and masonry (Picture 2).

Hull High School, arrow indicates wind-driven rain from Northerly direction impacting courtyard doors shown in Picture 2

1. Make repairs to exterior doors in courtyard, replace weather-stripping as needed. Monitor for continued leaks and make further repairs as needed.
2. Continue to monitor gym/foyer areas for leaks to ensure repairs are adequate, make further repairs if necessary.
3. For more information about mold consult the US EPA's "Mold Remediation in Schools and Commercial Buildings" published by the US Environmental Protection Agency (US EPA, 2008) (http://www.epa.gov/mold/mold_remediation.html).
4. Refer to resource manual and other related IAQ documents located on the MDPH's website for further building-wide evaluations and advice on maintaining public buildings. These documents are available at: <http://mass.gov/dph/iaq>.

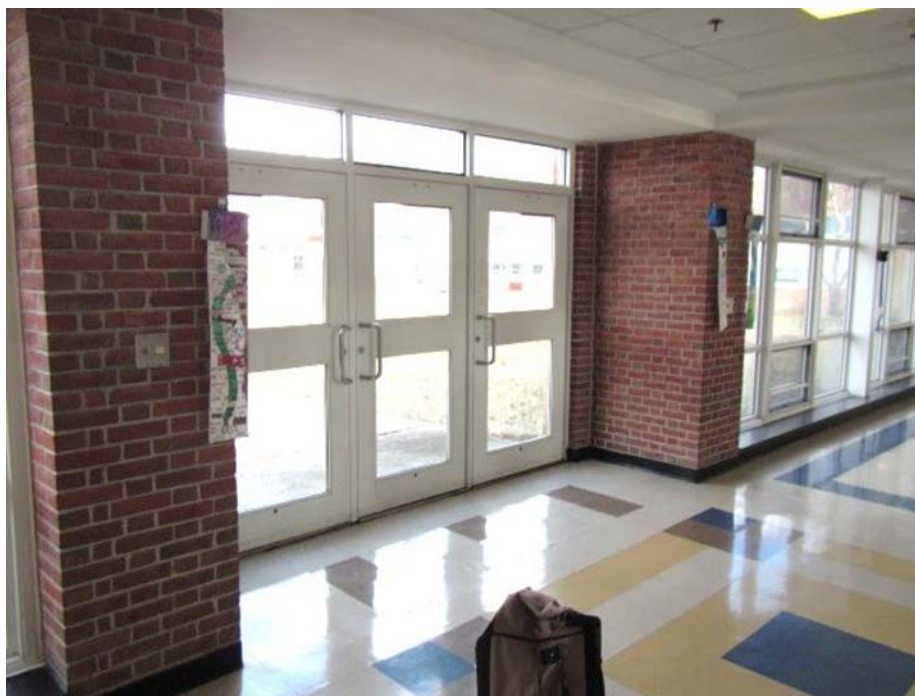
Picture 2

Interior view of courtyard access doors

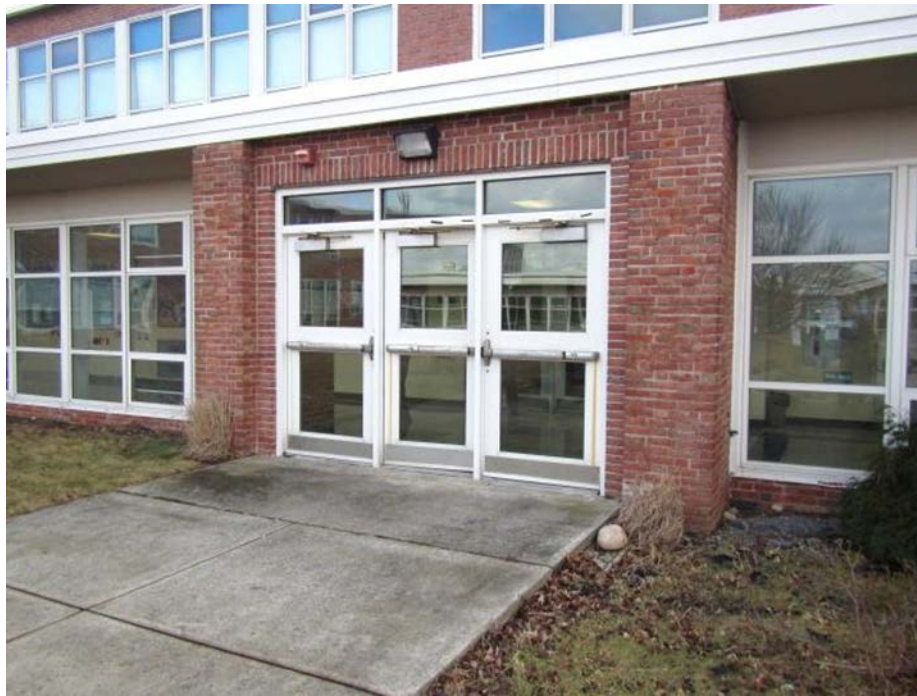
Picture 3

Exterior view of courtyard access doors

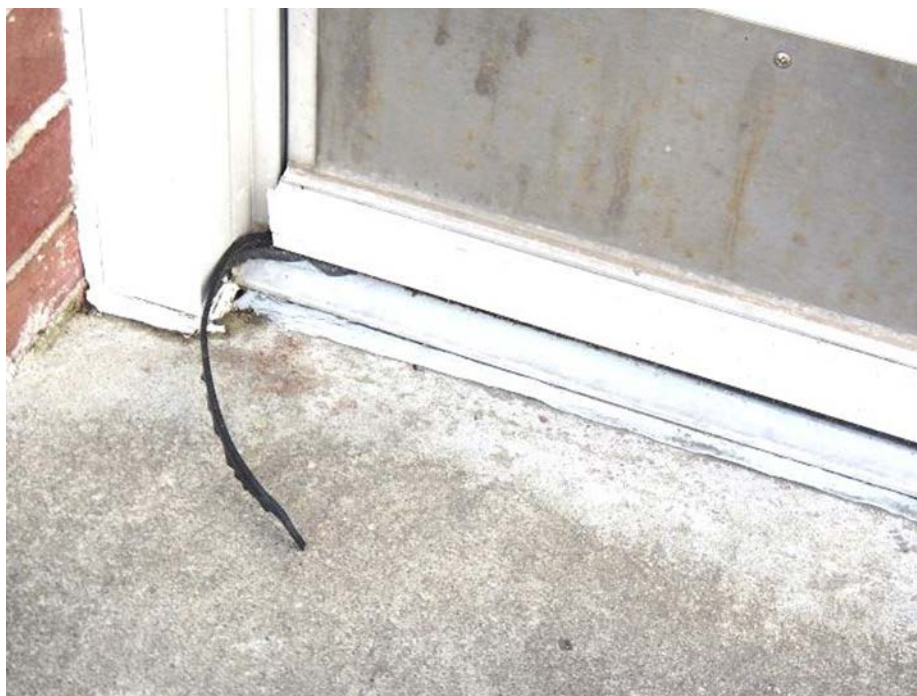
Picture 4

Loose/damaged weather-stripping on exterior courtyard access doors

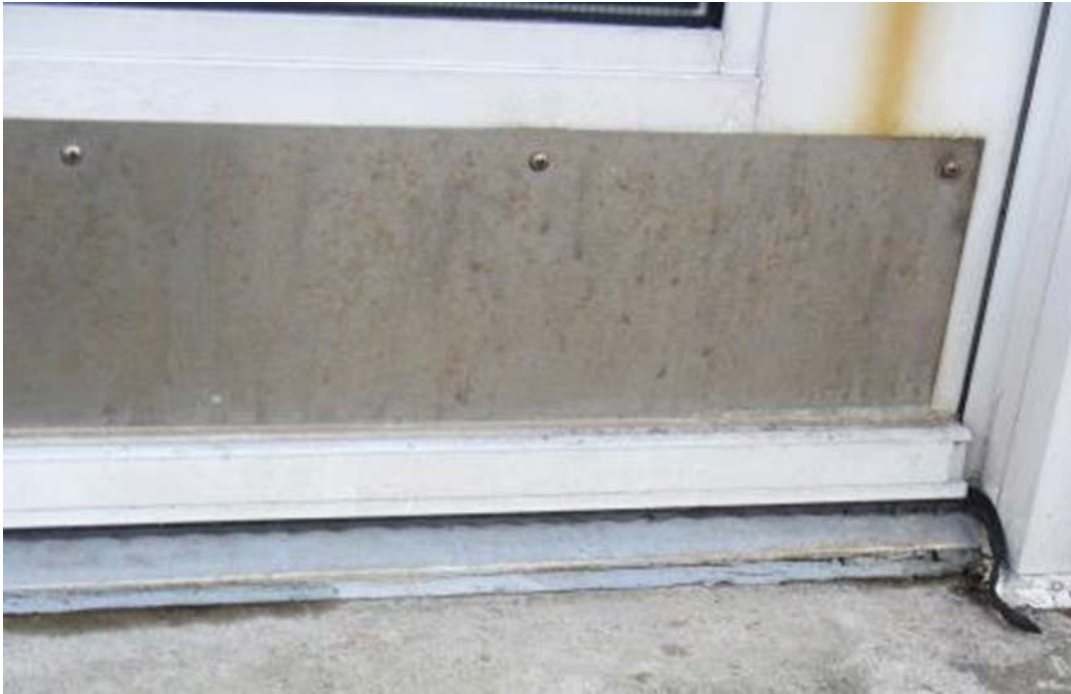
Picture 5

Loose/damaged weather-stripping on exterior courtyard access doors

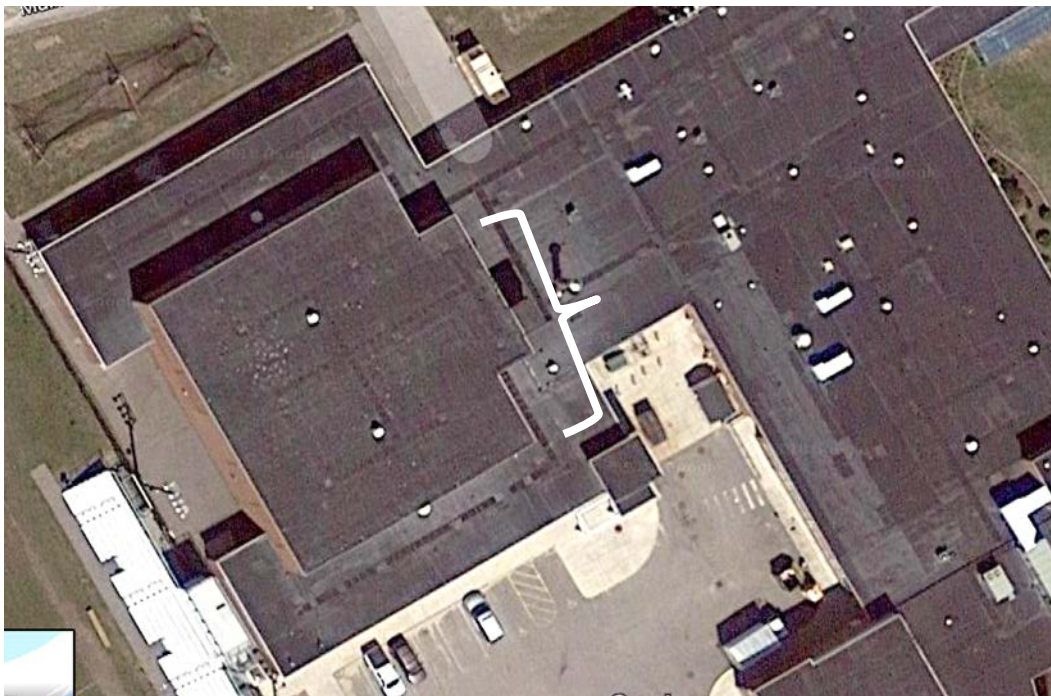
Picture 6

According to school officials the foyer/entrance to the gym area has been a point of chronic leakage (Picture 6), however over the summer/fall of 2017, many areas along the exterior

Bracket indicates approximate area of gym foyer where water penetration has occurred

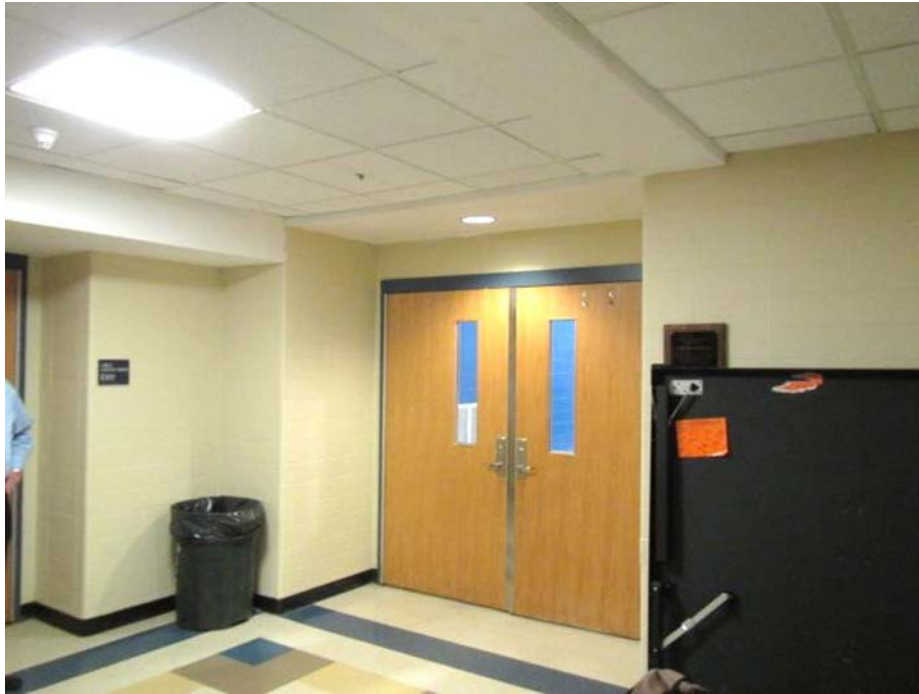
Picture 7

were repointed/weather-proofed. At the time of assessment, gypsum wallboard and damaged ceiling tiles had since been repaired/replaced. The assessment occurred after a steady rain (reportedly heavy at times). All building materials were dry and no evidence of water damage/further leaks were observed in the gym/foyer area (Pictures 7 and 8).

Gym foyer area of previous leaks, no further signs of water damage on building materials

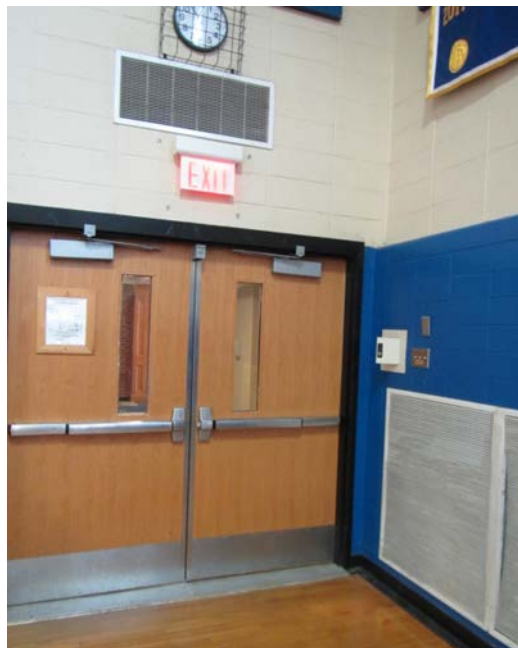
Picture 8

Gym area directly inside area of leaks, no evidence of water damage on building materials
